Urgent safety information

for LUISA, TIVAN LS, Life One (LM150TD) ventilators

to urgent safety information (FSN-2024-01)
for the LUISA ventilator (LM150TD)

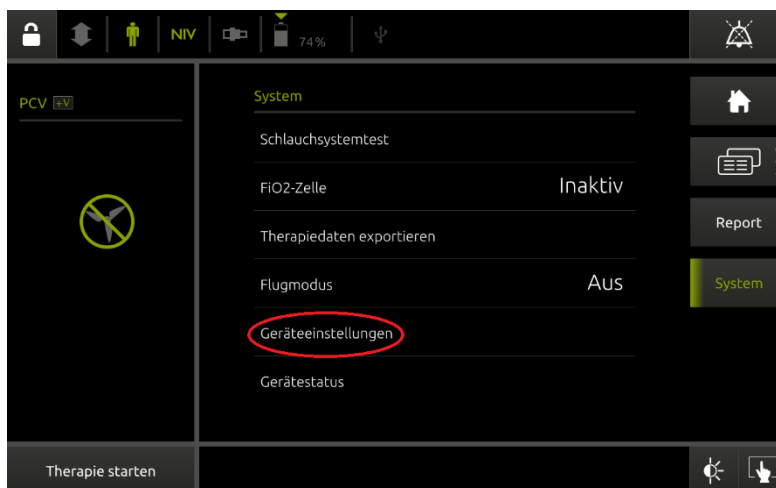
2. Then go to "device settings":

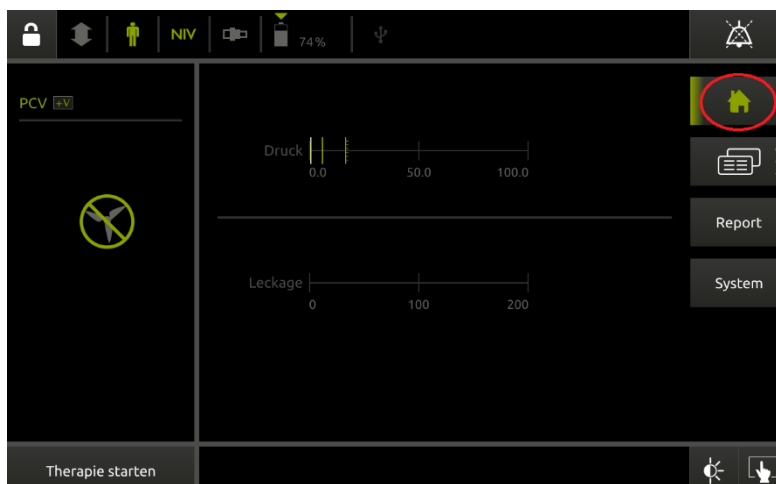
5. Press the home button to return to the main menu:
